# **TOWN OF SOUTHBRIDGE**

## **Municipal Facilities**

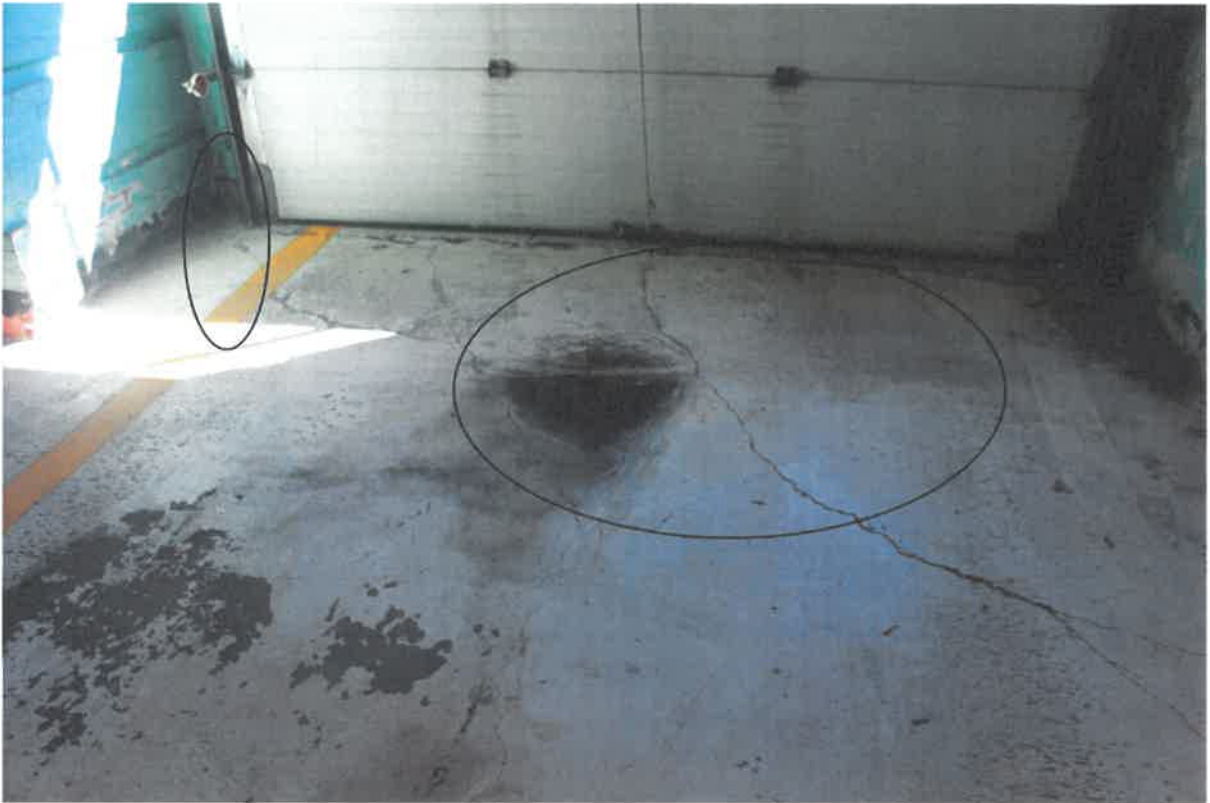
3.1 Bay 5 floor failure In corner failure radiates up brick wall

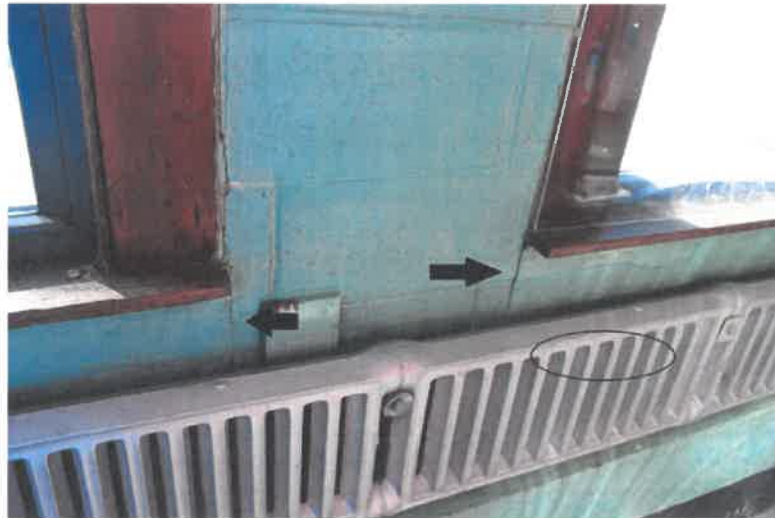
3.1 Bay 6 exterior wall stress crack through brick and block. Radiator is not in service

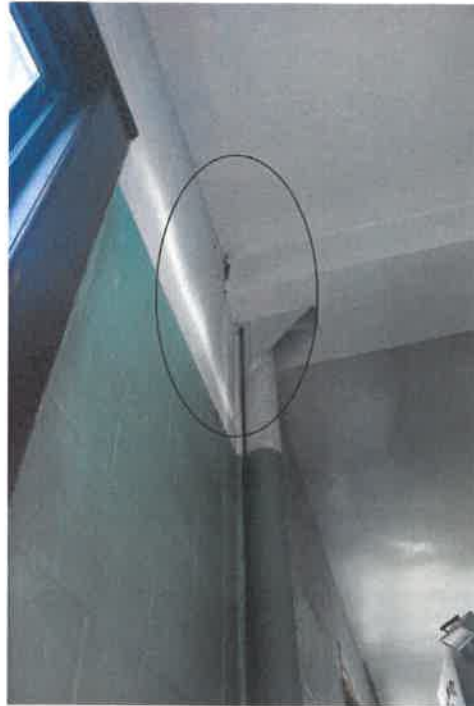
3.2 Interior beam at exterior addition wall pulling away from wall

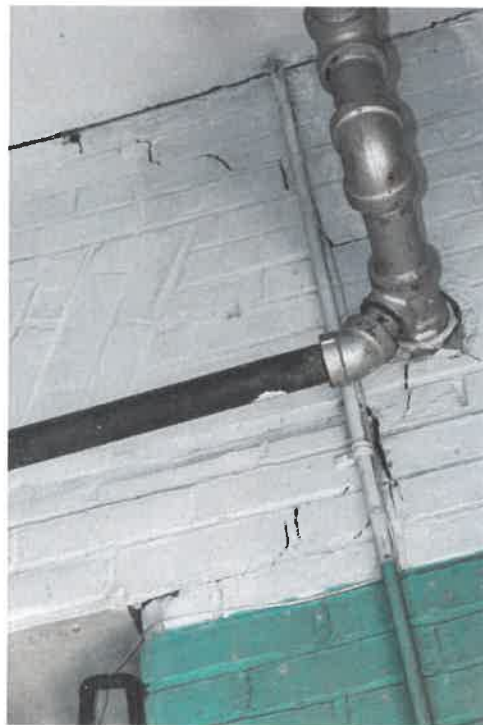
3.2 Addition building stress cracking of brick at interior wall

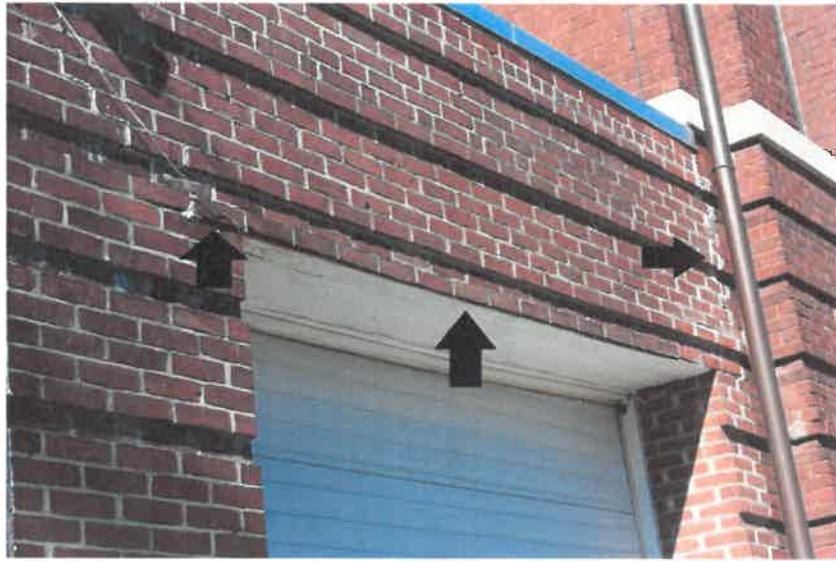
3.2 Bay 5 garage door lintel and mortar failure due to deflection, rusting and movement.

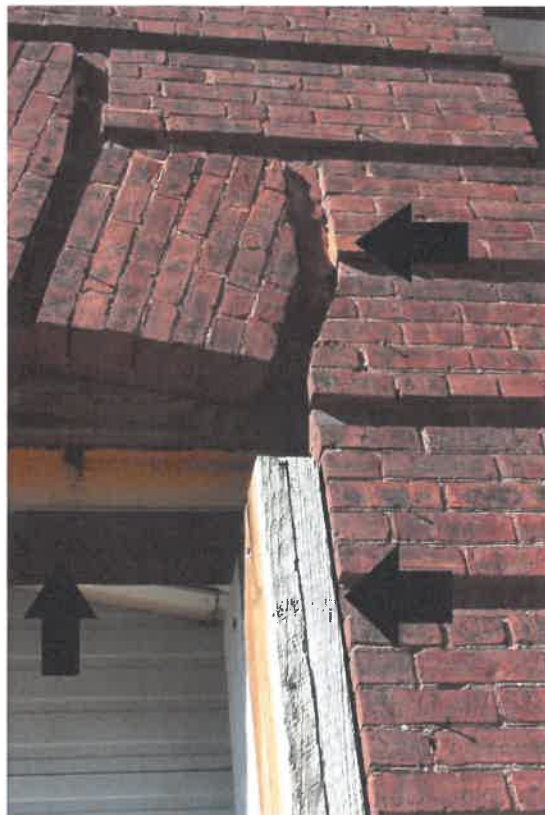
3.2 Added exposed lintel (rusting). Wood support not engineer to support masonry. Upper arrow indicates mortar joints opening up

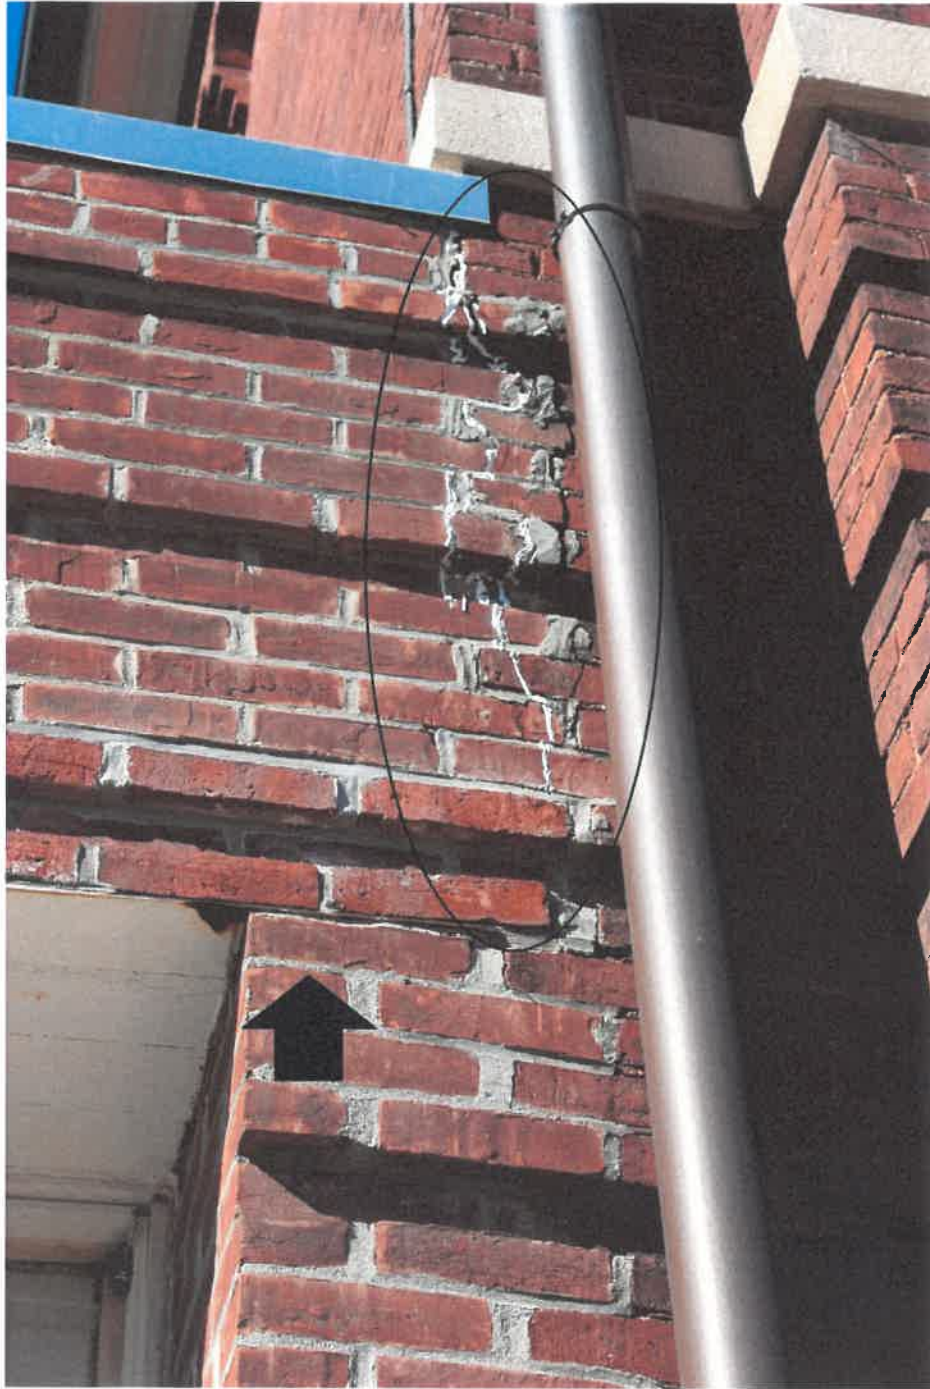
3.2 Significant brick movement and failure at front façade. Arrow shows rusting lintel that appears to have deflected and expanded opening mortar joint that has been filled with mortar.

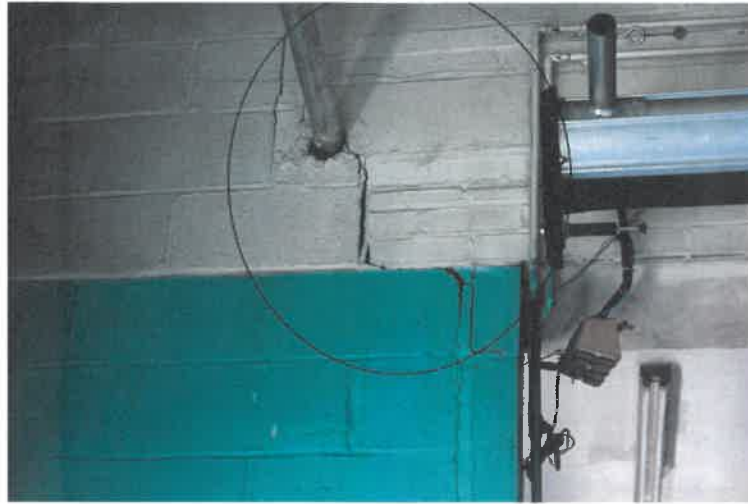
3.2 Interior wall of 1960 addition stress cracks at opening

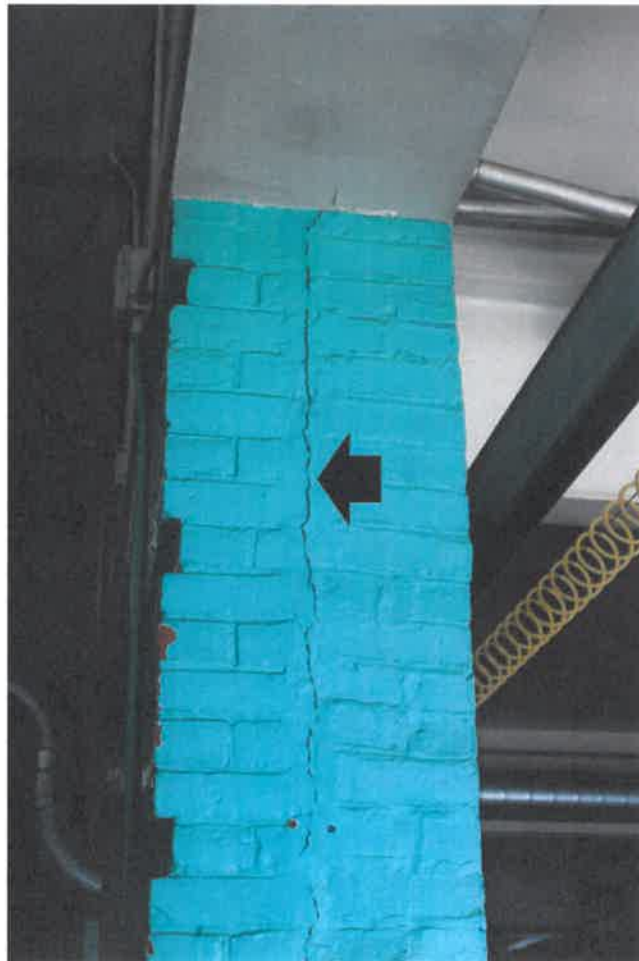
3.2 Interior column at original building/1960 addition stress crack of support column

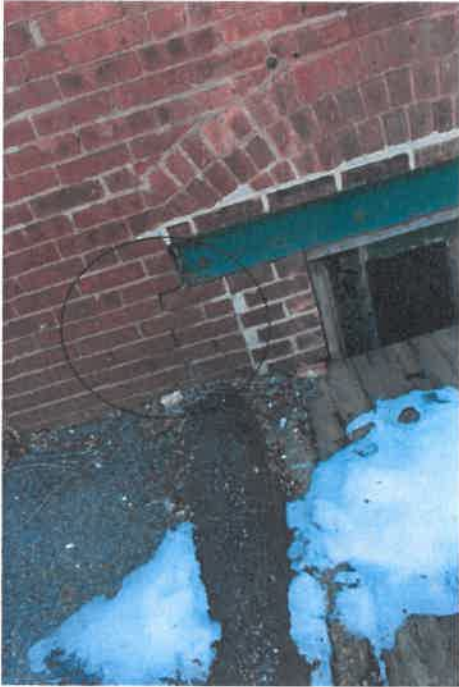
Main building basement floor lintel movement affecting brick

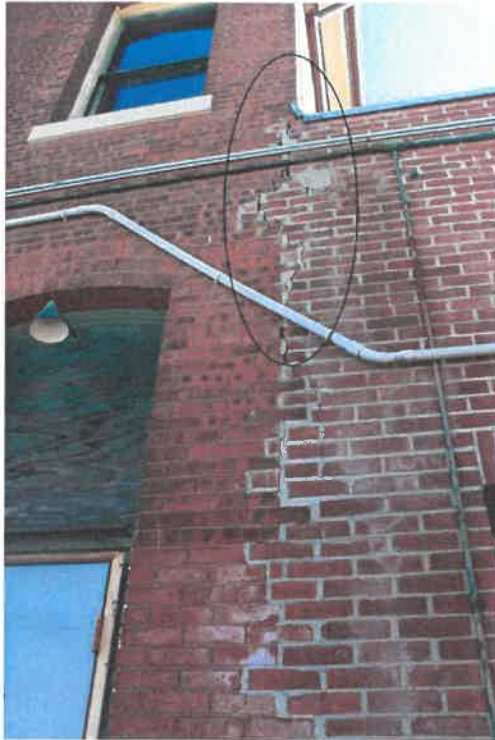
3.2 Significant brick movement main building at 1940s addition. Excessive water infiltration is occurring causing efflorescence and continual failure.

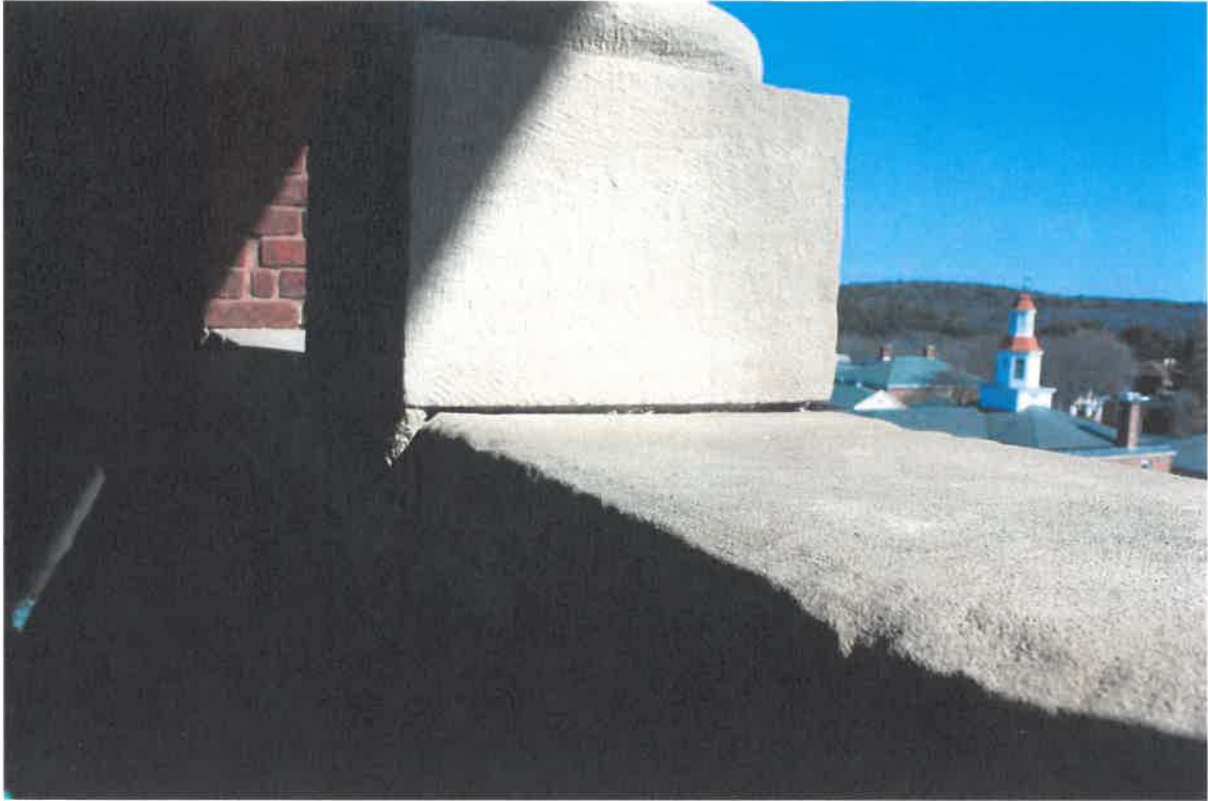
3.2 Tower column missing mortar

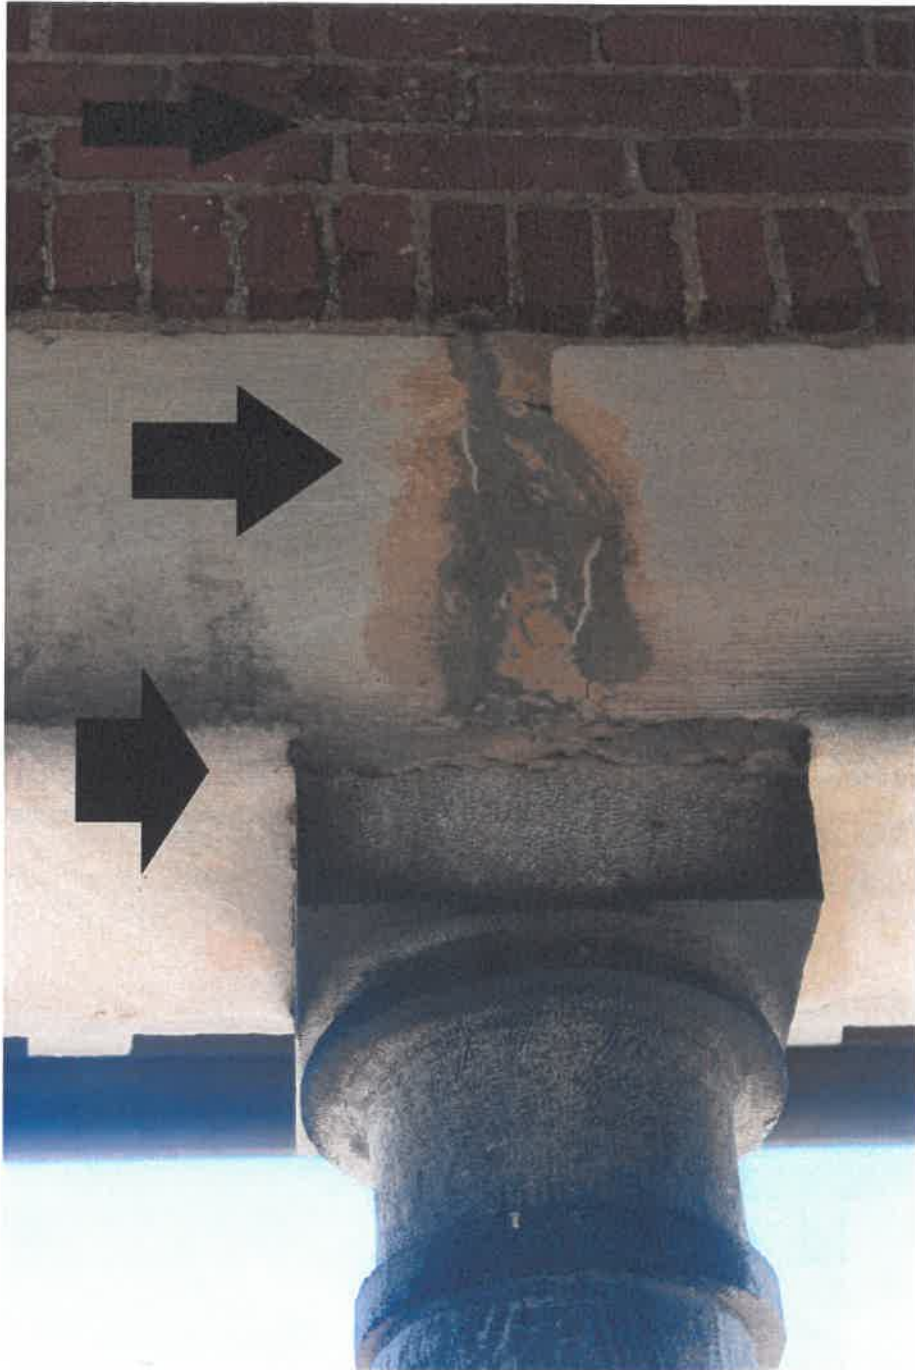
3.2 Upper area cracking in brick joints due to movement

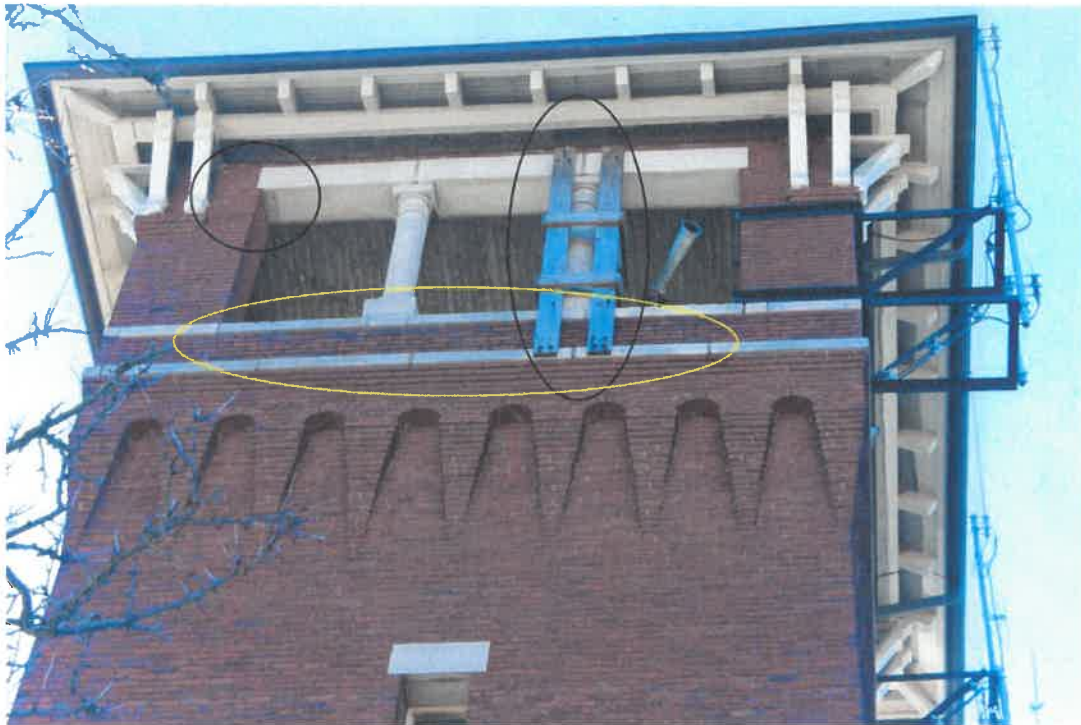
3.2 Wood Temporary support. Concrete lintel support area of concern. Brick and mortar damage (yellow) causing upper cast stone movement. Note: critical communications equipment on right

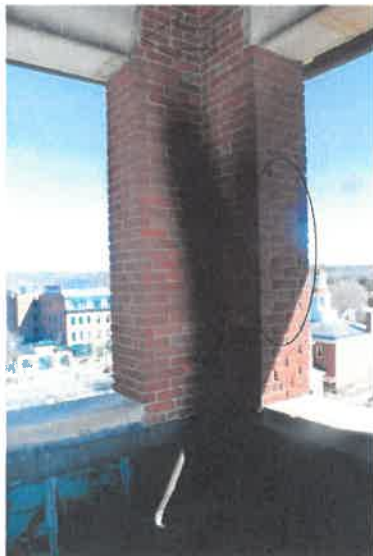
Arrow Upper cast lintel with minimal support patched  
Circle typical mortar failure.

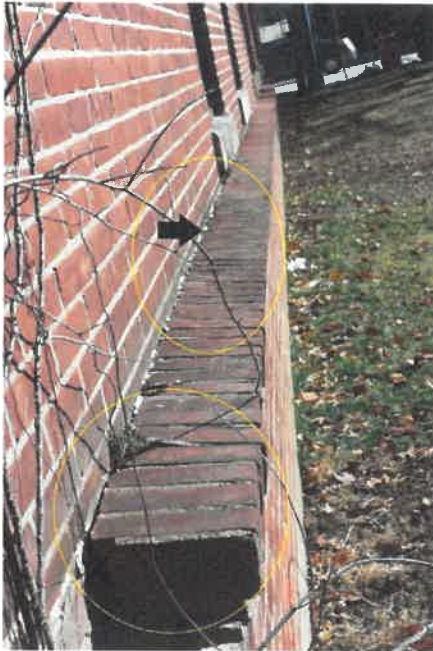
3.3 1960 Brick shelf improperly flashed and failing. Caulk joint (arrow) failed, but not a proper application

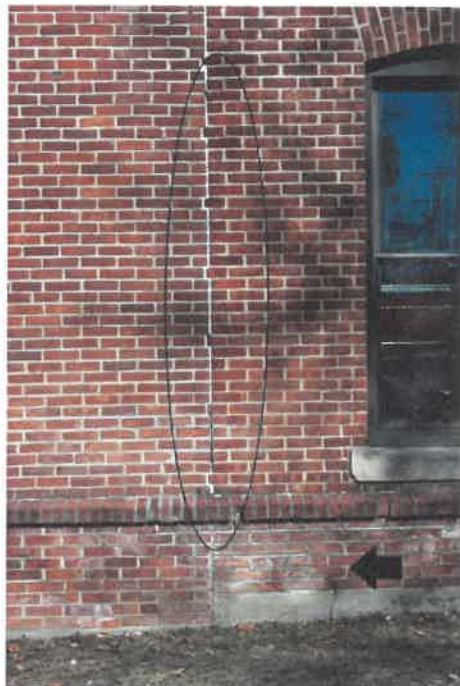
3.3 1960 addition Foundation cracking.(arrow) Brick wall joint failure.

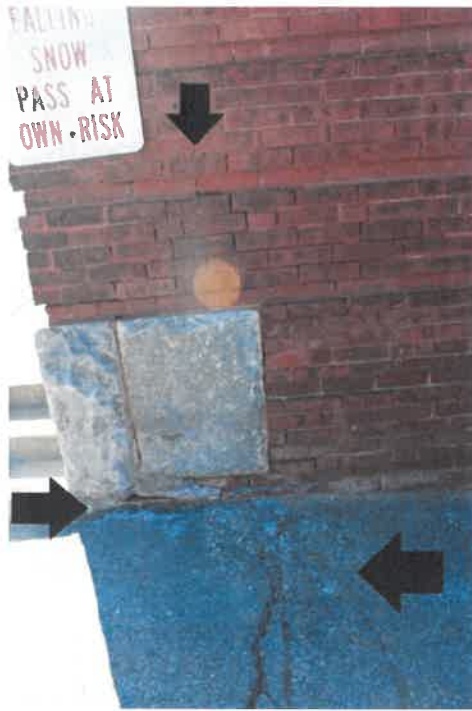
3.3 Typical mortar failure. Cornerstone stress cracking and poor mortar repairs

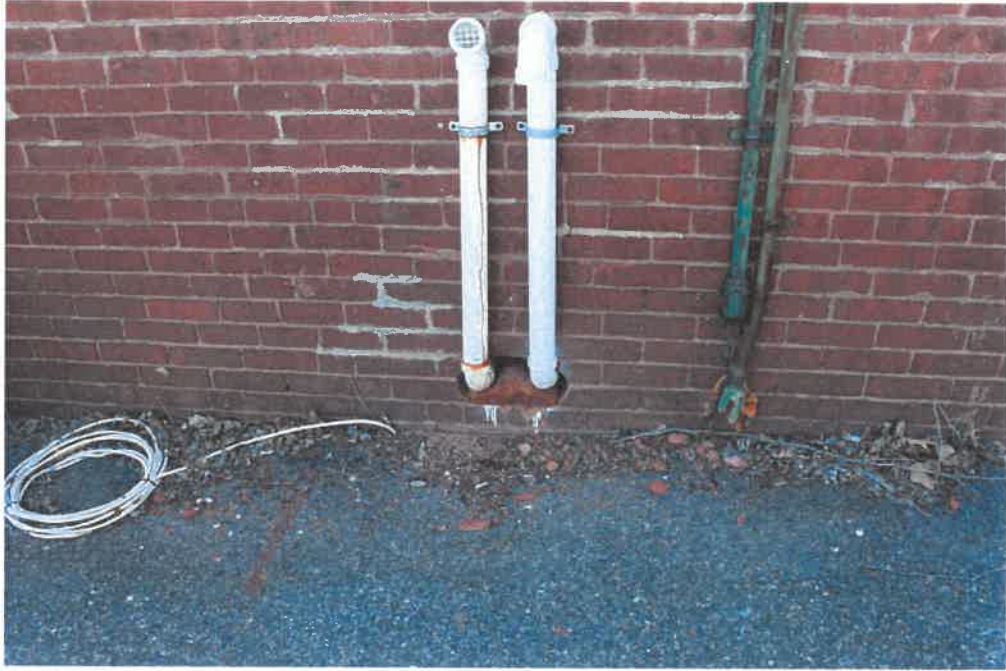
Typical mortar failure around doors

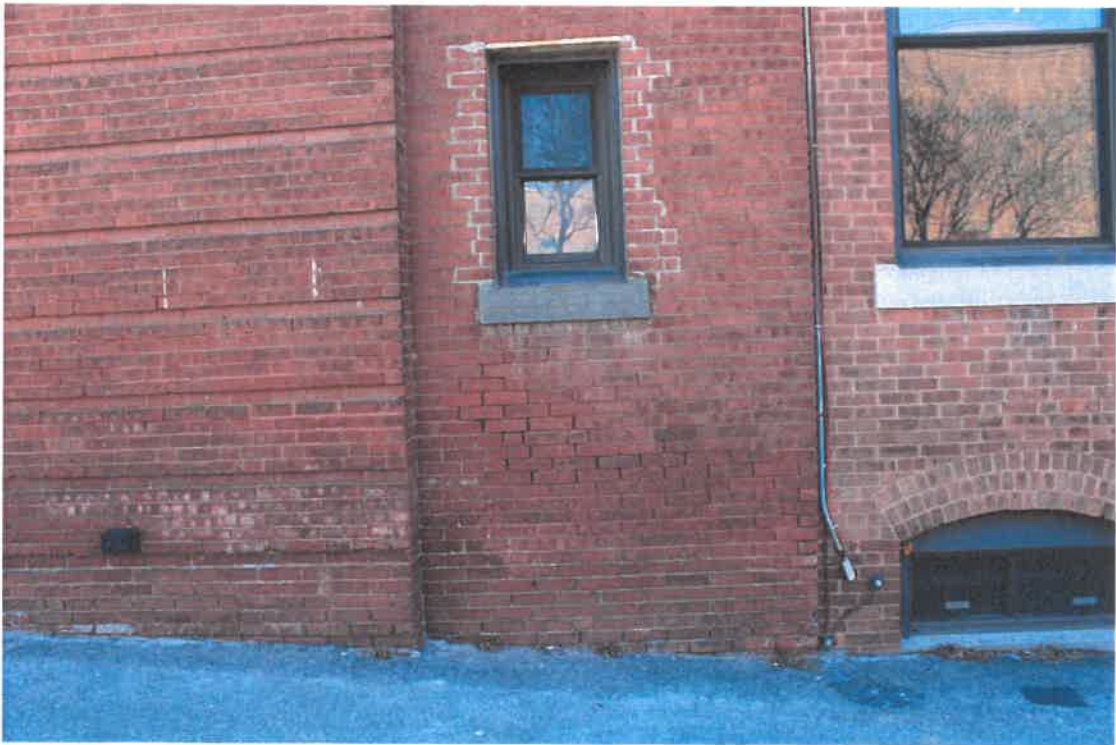
3.3 Typical areas of significant missing grout

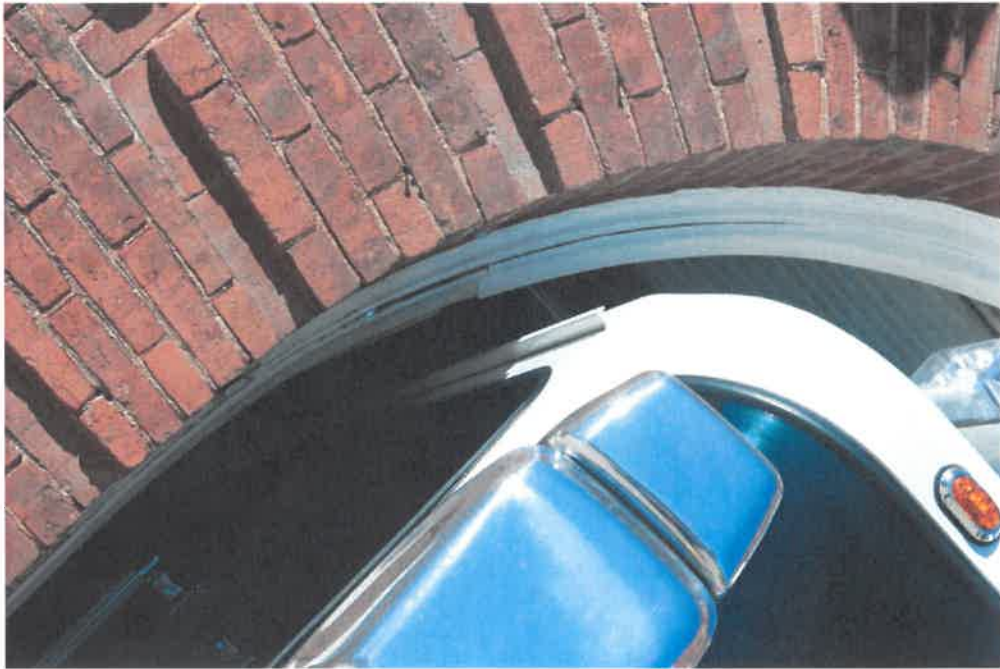
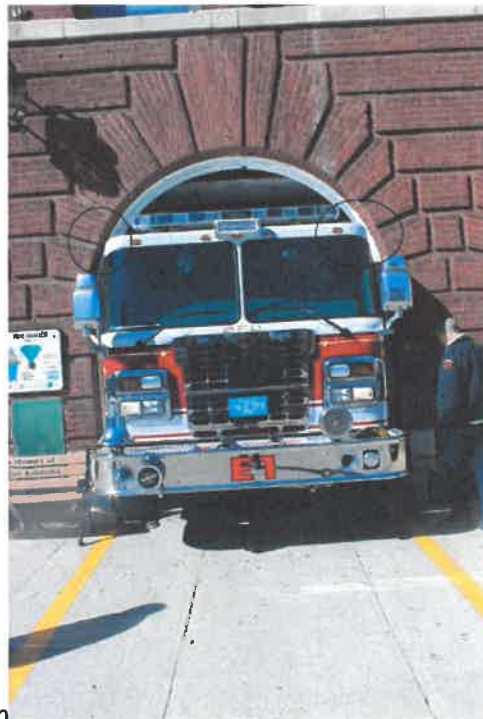
### 3.3 Door opening too small for operation

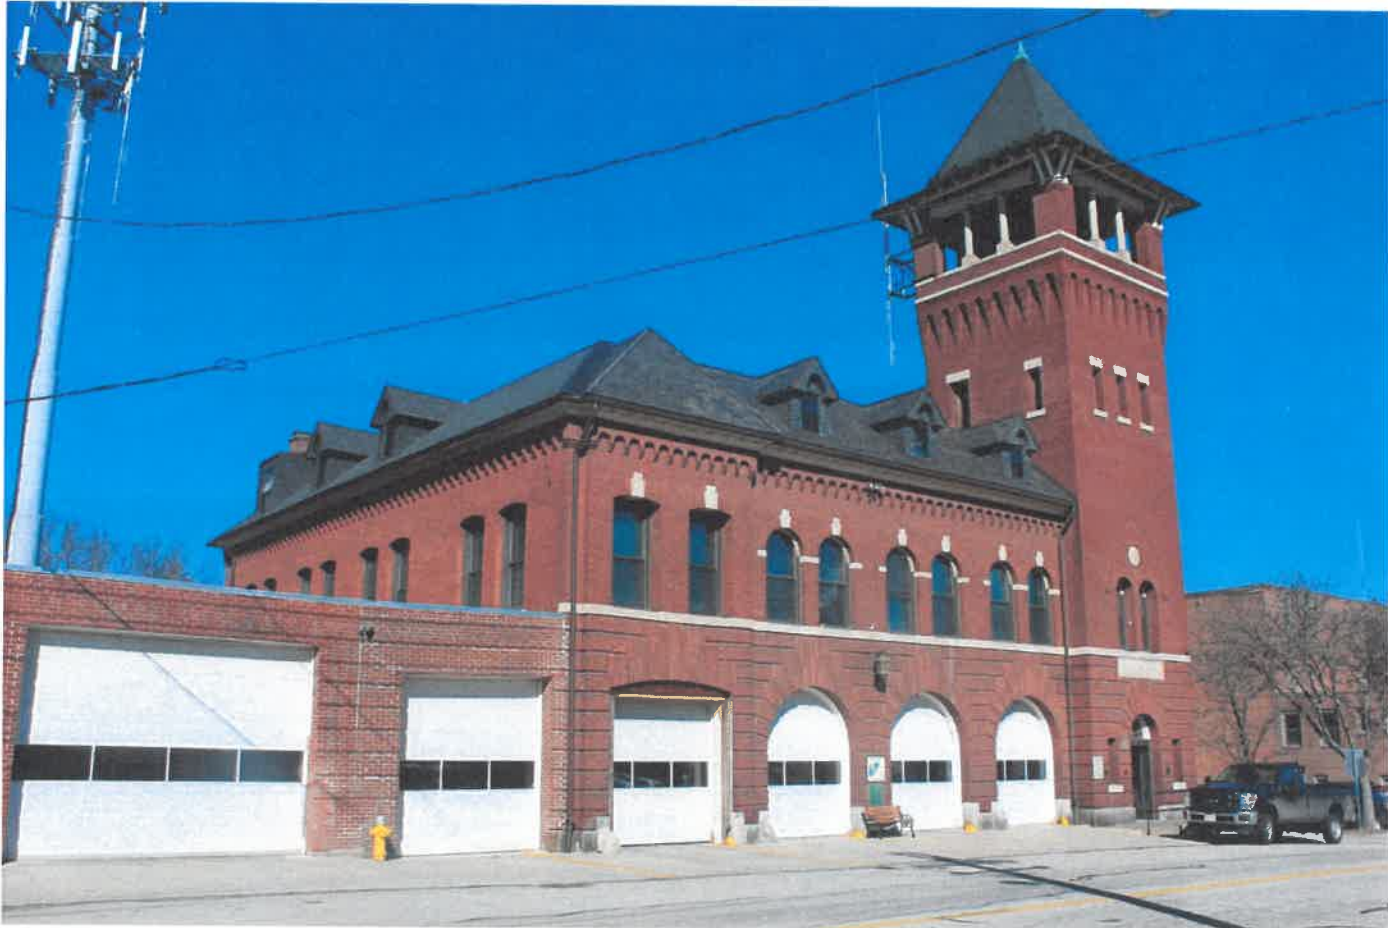
3.3 Southbridge Fire Station Masonry

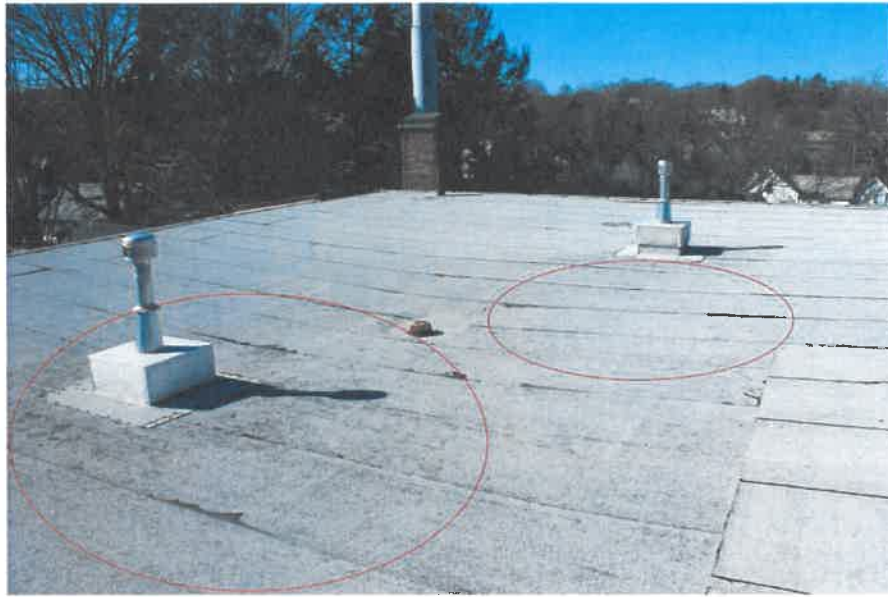
3.4 Apparatus bay roof. Roof granular stone facing is worn thin

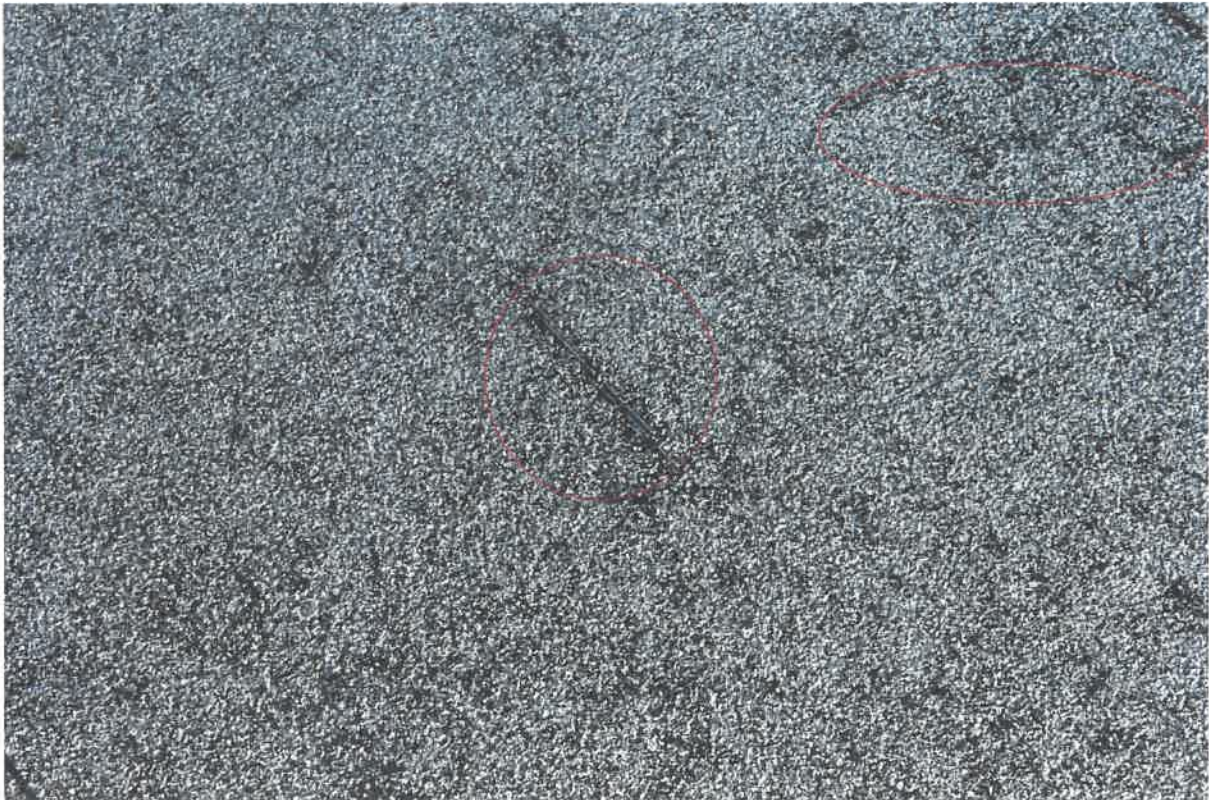
3.4 Detail of worn granular stone exposing fiberglass reinforcement.

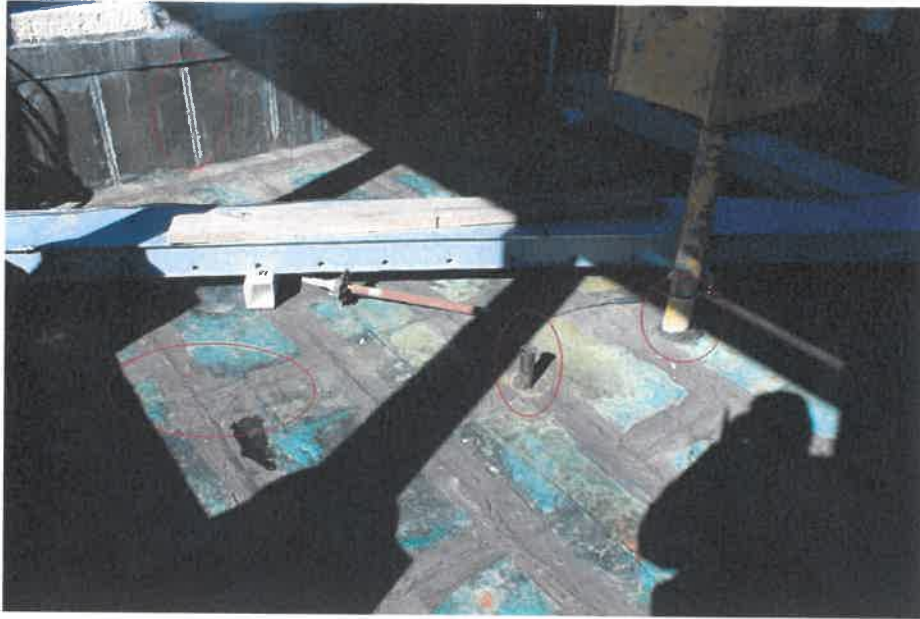
3.4 Tower Copper pan roof. Copper seams failing, undersized emergency overflow, improper penetration flashing.

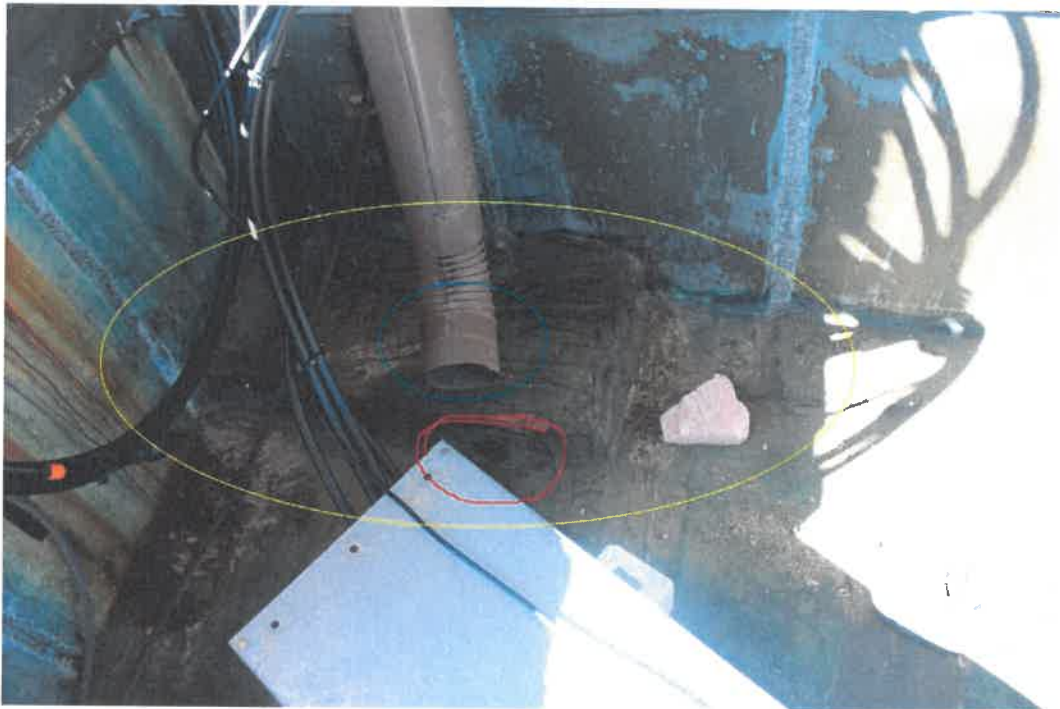
3.4 Tower roof drainage: Upper roof discharge (blue) overwhelms 1 1/2 Inch roof drain (red). Corner blocking has mastic over copper to prevent leaking, improper fix.

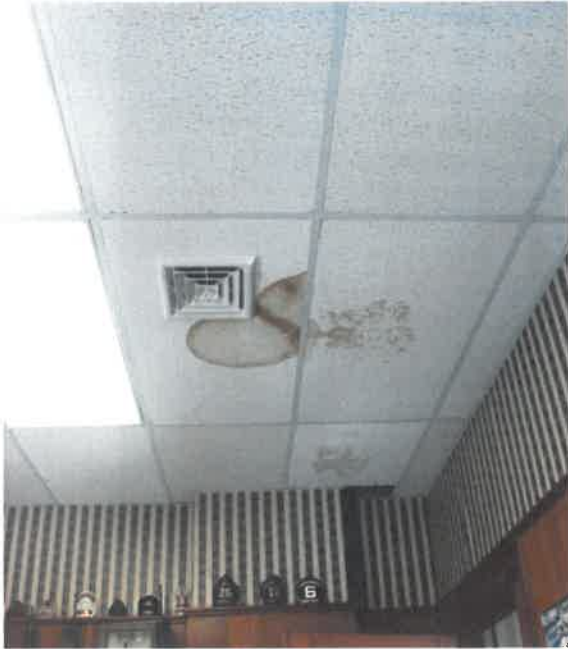
Leak of upper tower pan leaking into Fire Chief's office

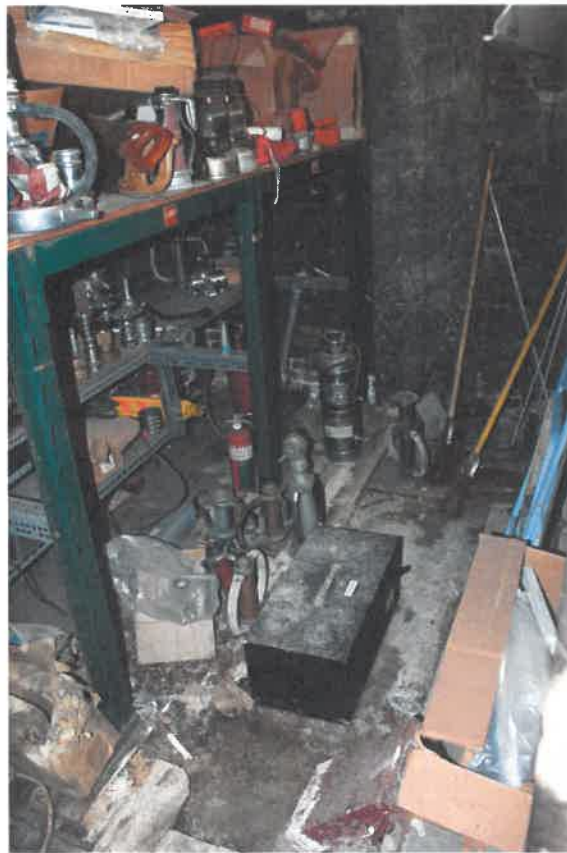
3.5 Basement storage affected by excessive moisture

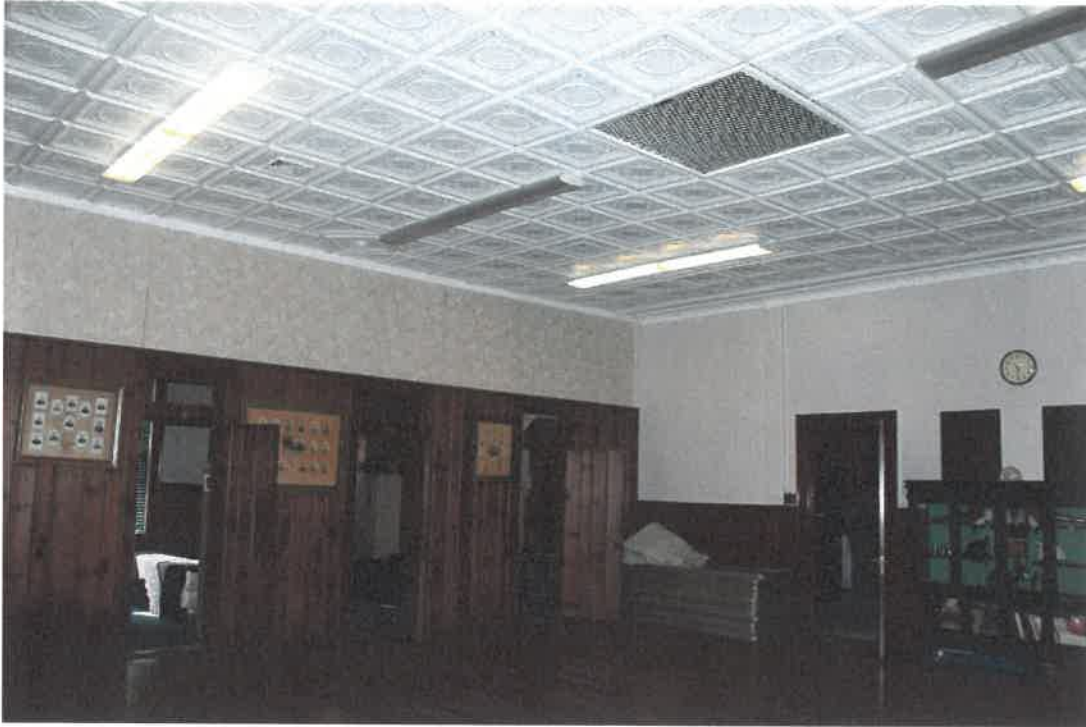
3.7 Second floor of fire station. Limited operational function

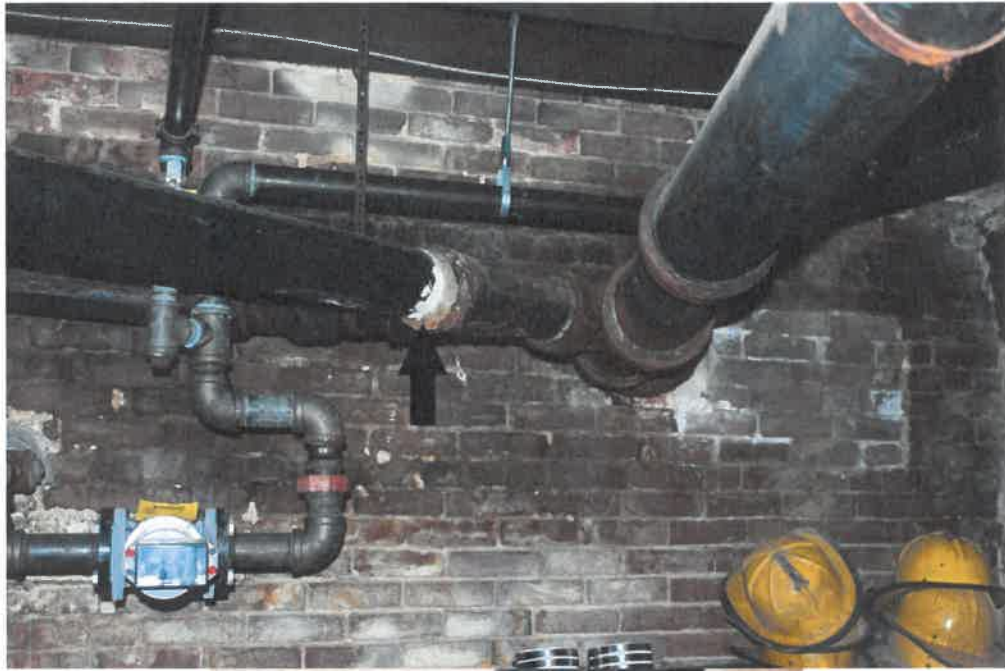
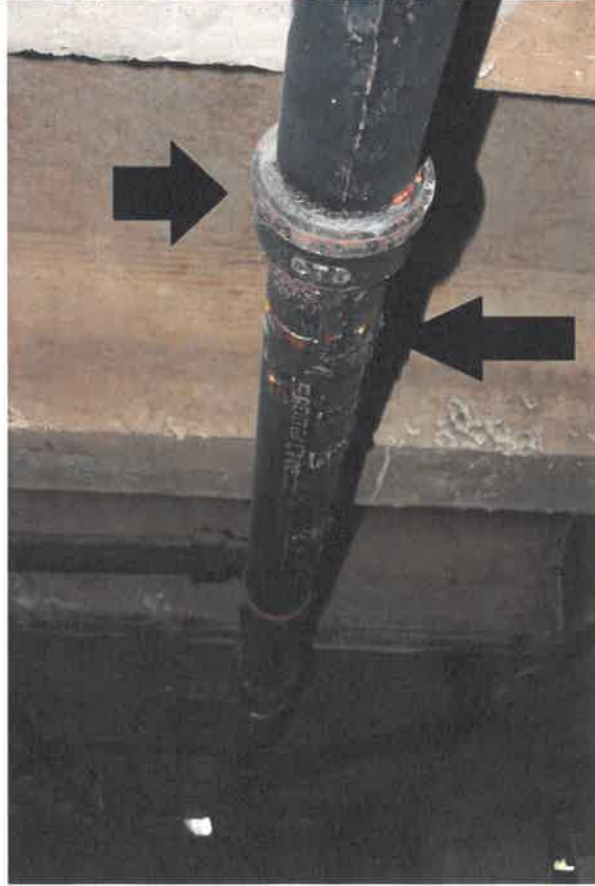
4.1 Leaking waste pipe joints and leaks in piping

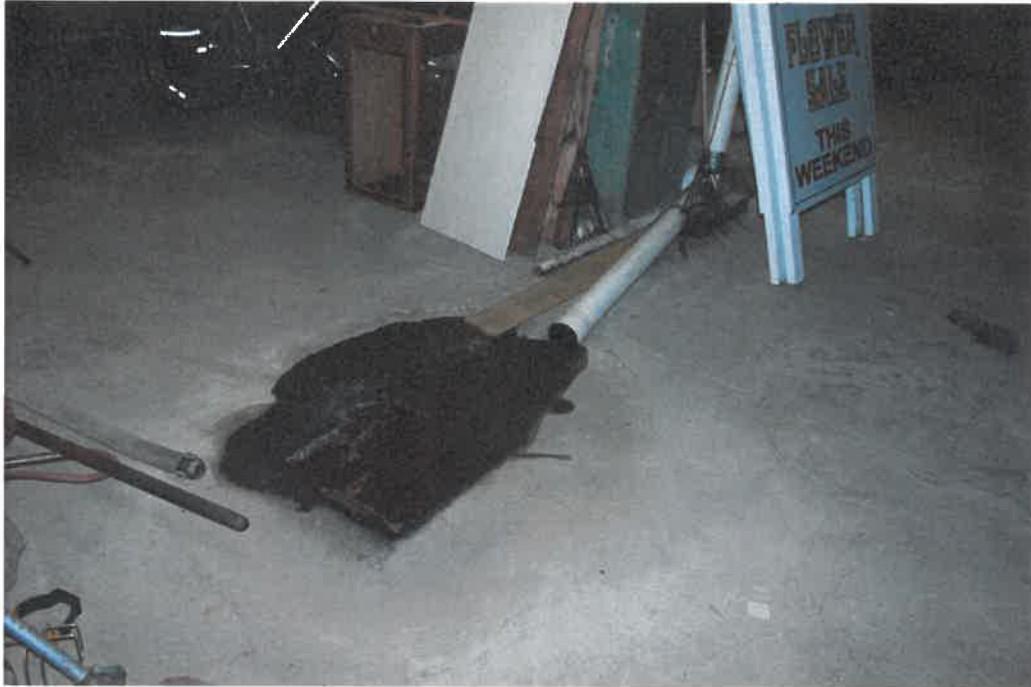
4.1 Make shift washing machine drain using the floor drain system

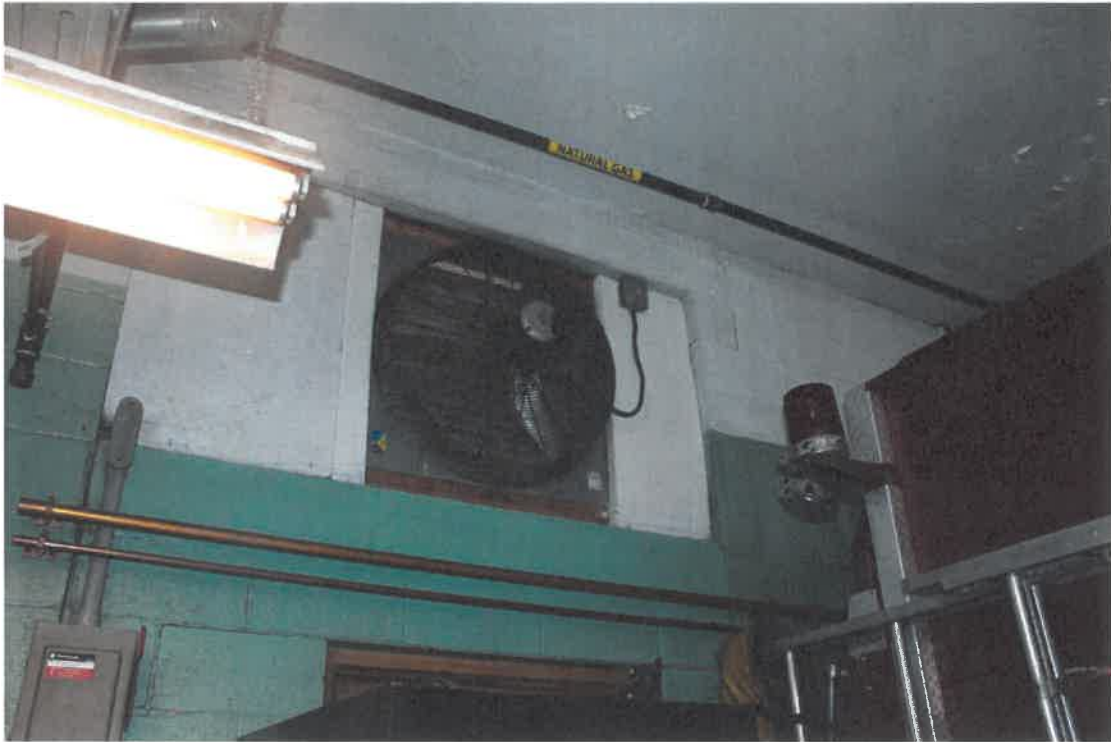
4.2 Added venting of apparatus bay due to excessive exhaust

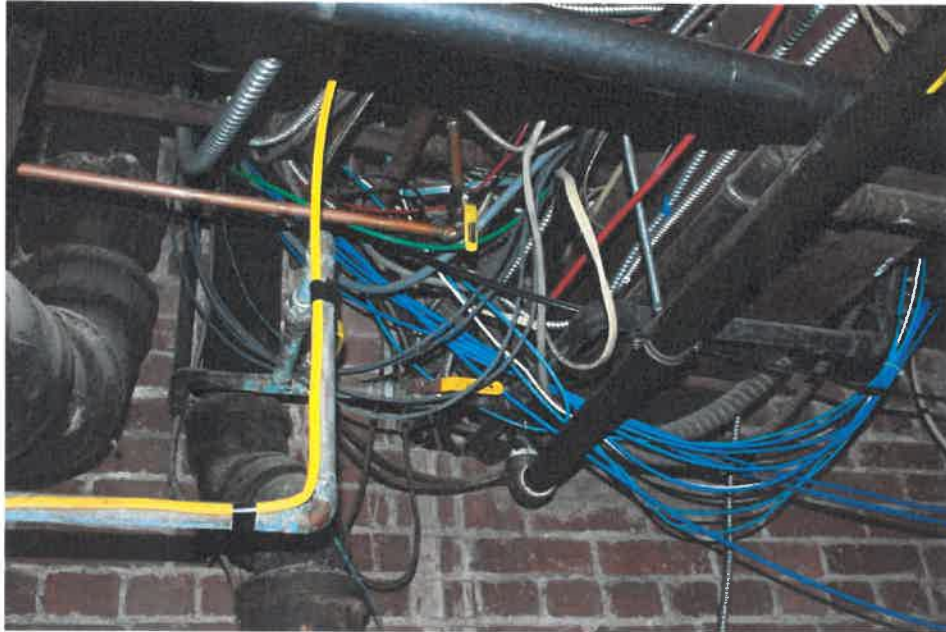
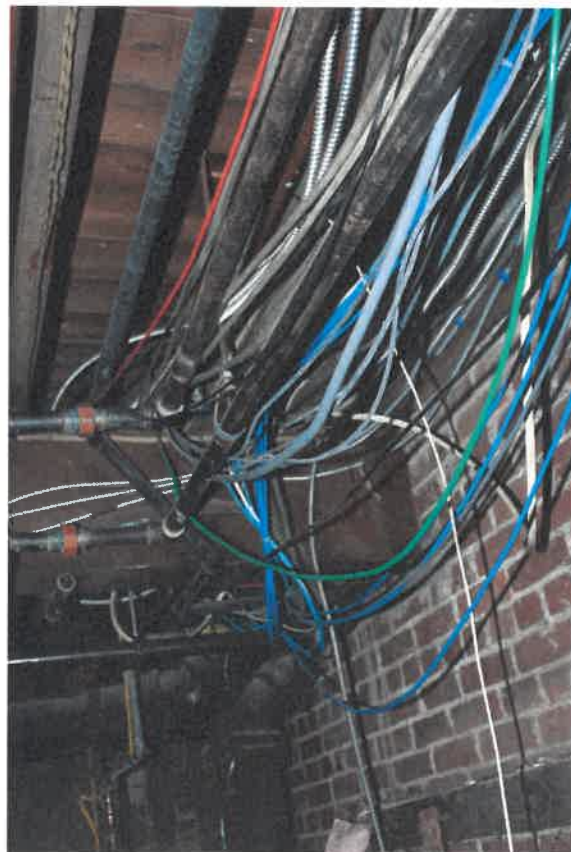
4.3 Electric and communication wiring improperly installed and in violation of electric codes and practices.
