# **TOWN OF SOUTHBRIDGE**

## **Municipal Facilities**

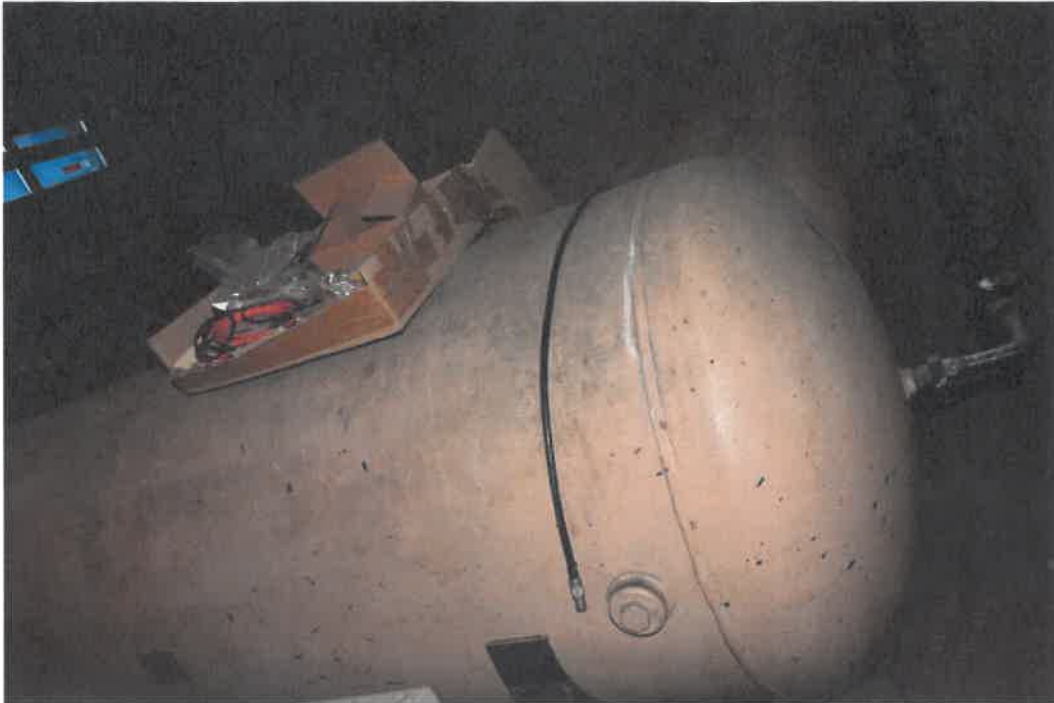
Operation air horn tank not in compliance with State of Massachusetts pressurized tank standards

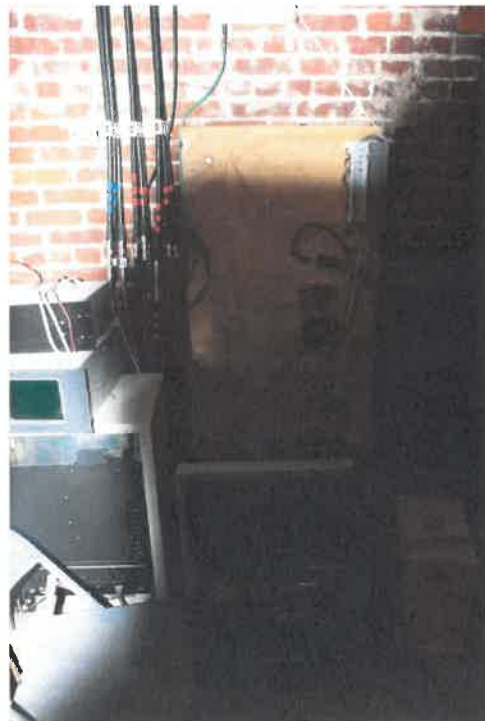
4.3 Communication equipment in upper tower attic. Concern is questionable roof pan has leaked and could affect equipment

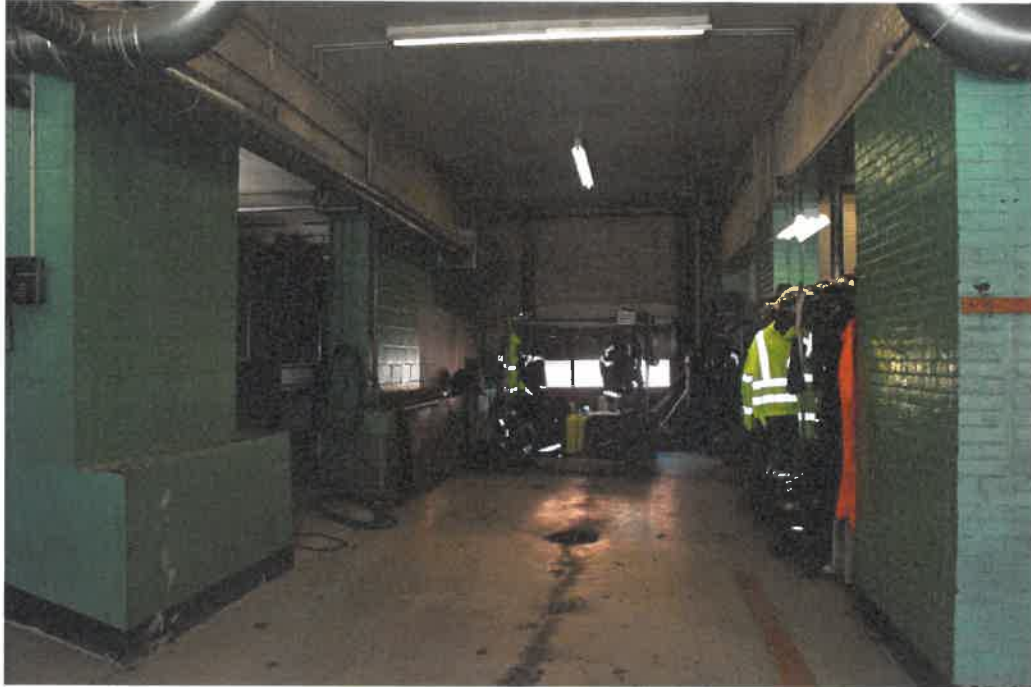
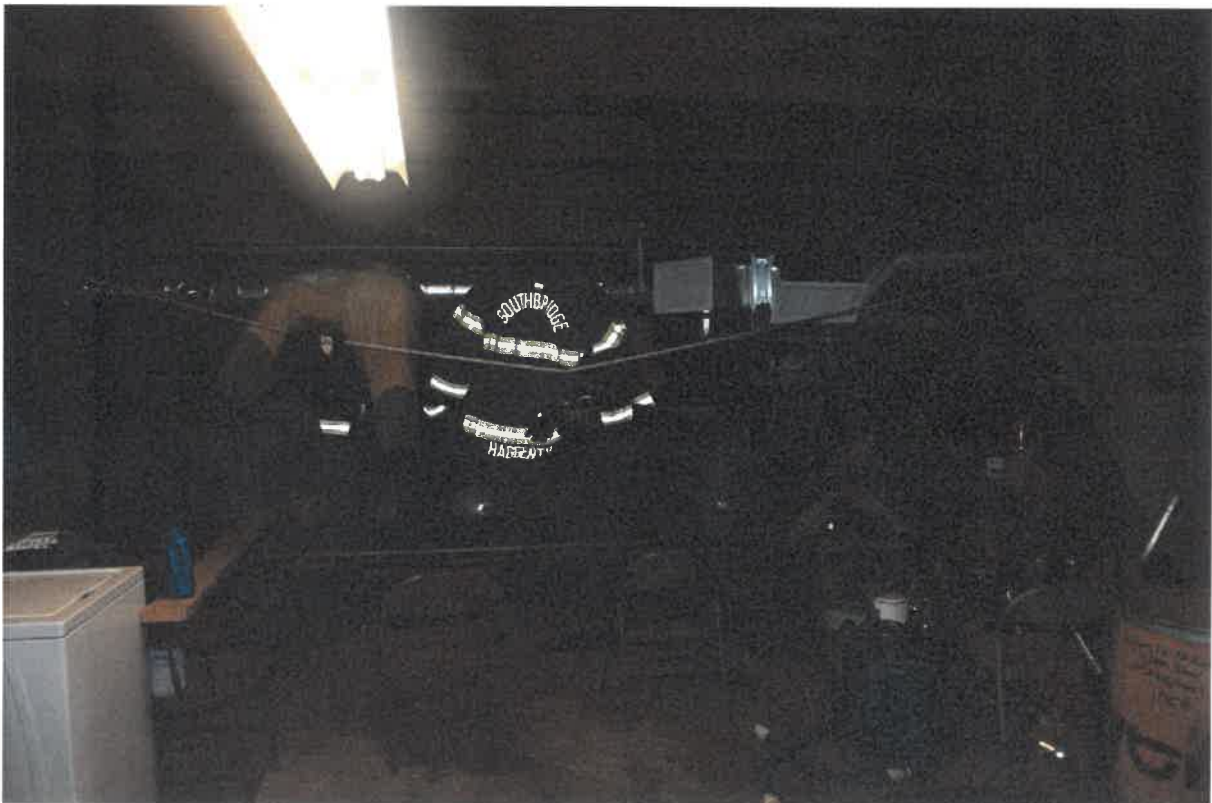
5.0 Fire fighter gear stored in active apparatus bay and makeshift basement level equipment drying operation

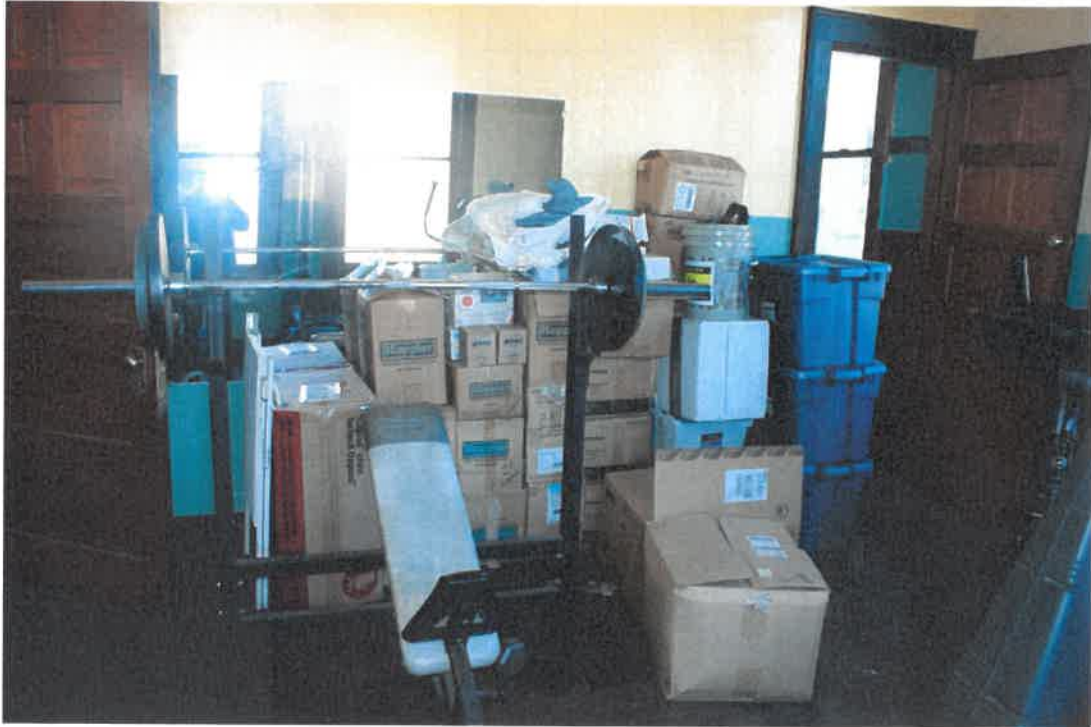
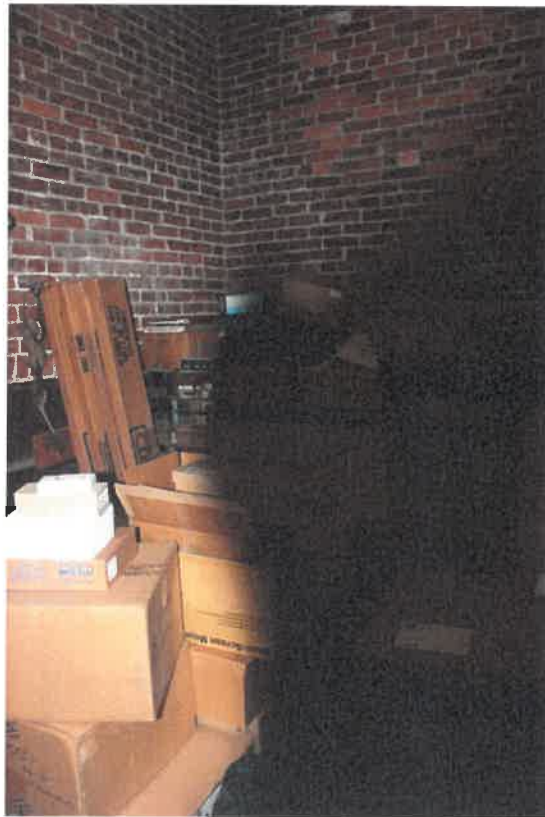
5.0 Typical lack of operational storage
